This report was created exclusively for

HAPPY HOMEBUYER

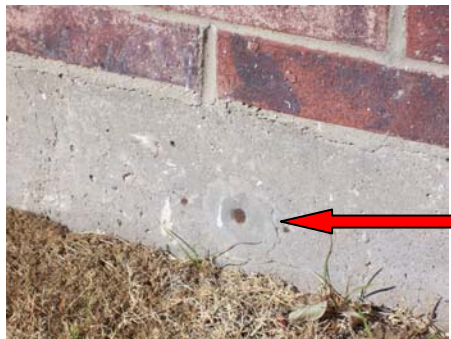
Exposed post tension cable ends were located on the north side of the foundation wall.

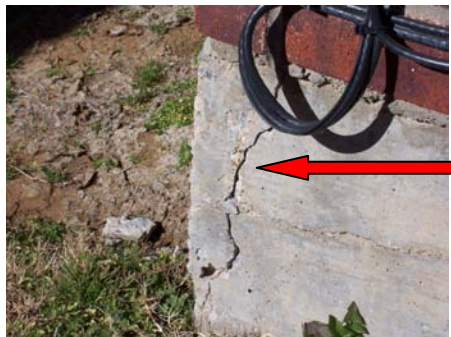
Spalling was observed on the west corner of the foundation wall.

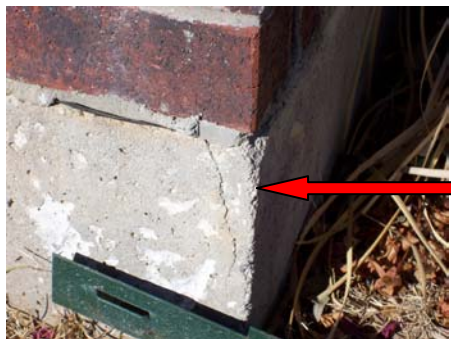
Spalling was observed on the west corner of the foundation wall.

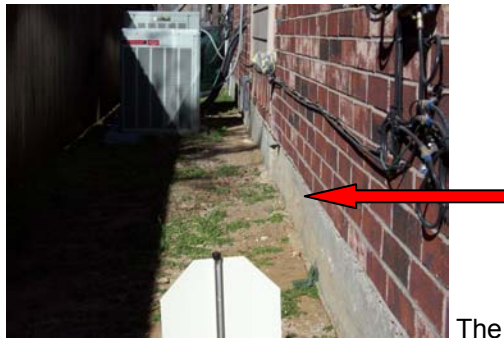
The sprinkler system on the north side of the home appears to have caused the soil to erode away from the foundation wall.

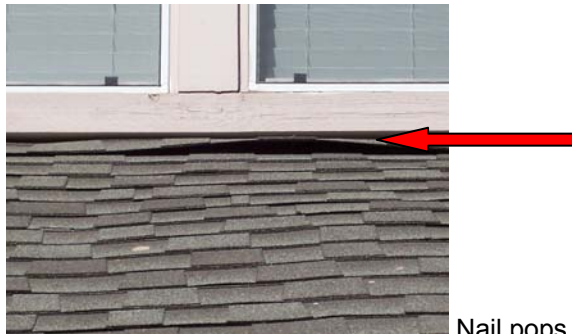
Nail pops were observed lifting the roof covering on the west side of the roof.

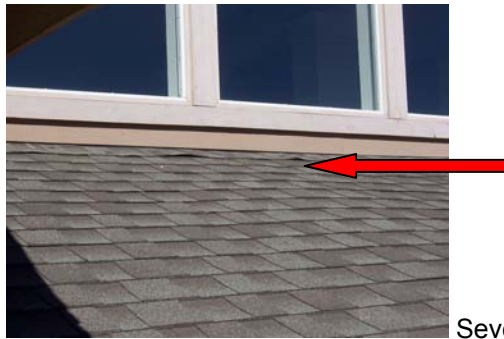
Several areas of the roof covering were observed with nail pops.

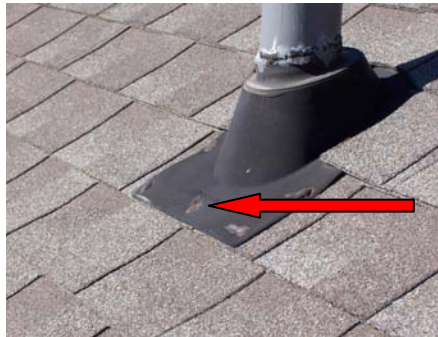
Exposed nail heads were observed in the flashing and boots used for the drain and vent stacks.

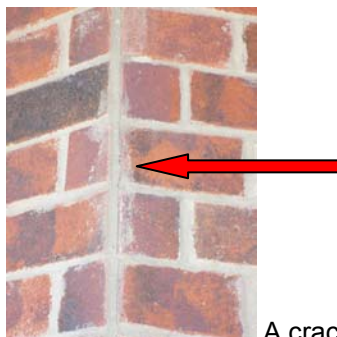
A crack was observed in the veneer brick located on the west side of the home.

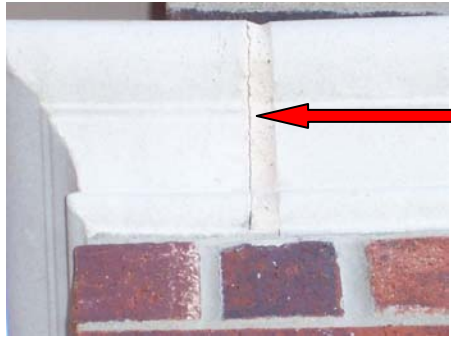
Several small cracks and missing mortar were observed in the accent bricks located on the east side of the home.

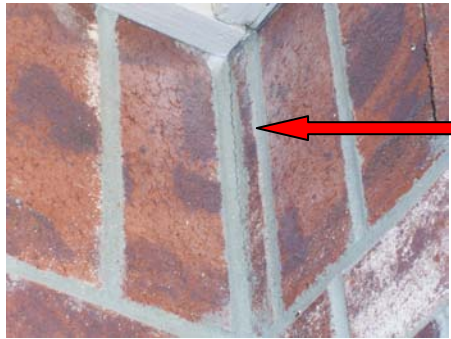
A crack was located in the mortar between two exterior walls located on the east side of the home.

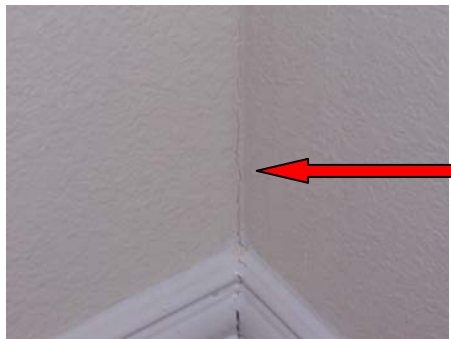
Several small cracks were observed in the corners of the internal walls and trim molding.

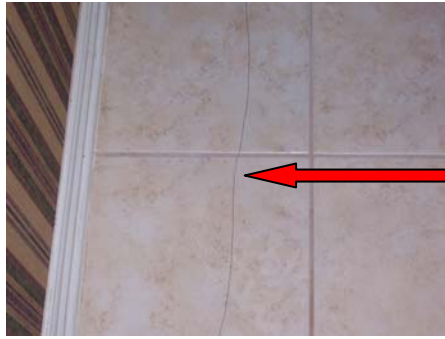
Tiles in the guest bathroom are cracked; this appears to be from foundation settling.

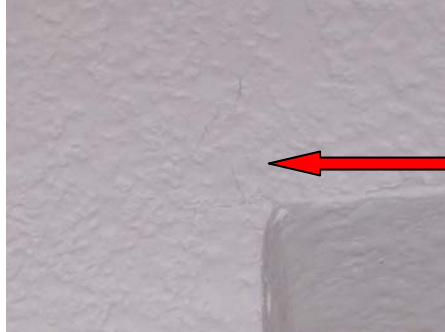
Several corners of the ceilings in the home are showing cracks from settling of the foundation.

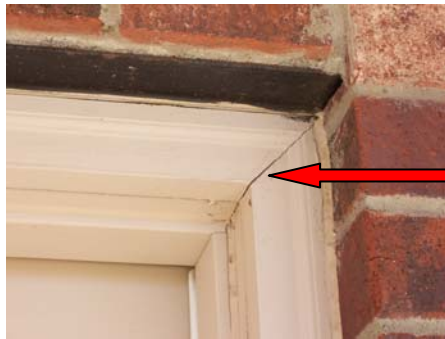
The door frame on the west side of the home shows signs of foundation settling.

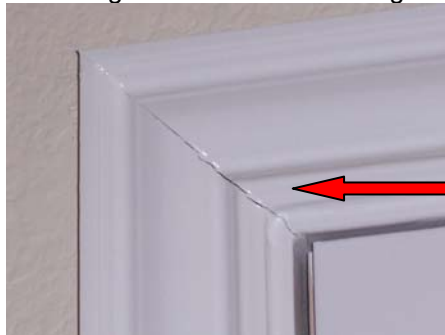
Several of the interior door frames show signs of foundation settling.

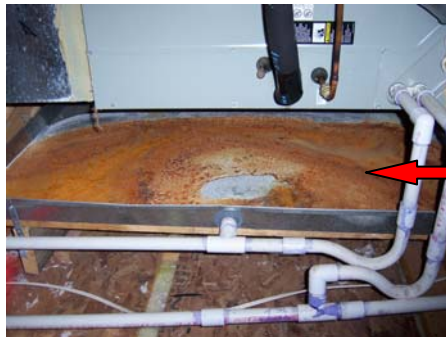
Drip pans located under the air conditioner unit are rusted from previous condensation.

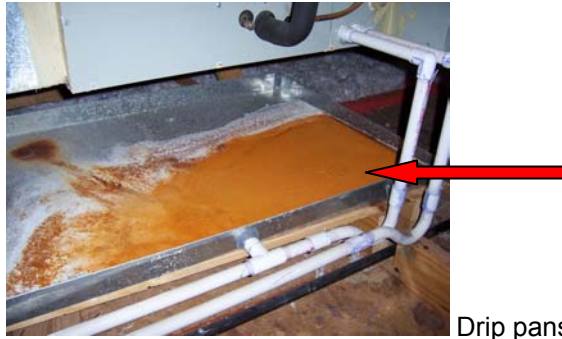
Drip pans located under the air conditioner unit are rusted from previous condensation.
